**Biological
Assessment
Letter Report**

BIOLOGICAL ASSESSMENT LETTER REPORT
FOR THE
3111 MANCHESTER AVENUE
CITY OF ENCINITAS

PREPARED BY:
Michael Jefferson
Senior Biologist
BLUE Consulting Group

February 7, 2020

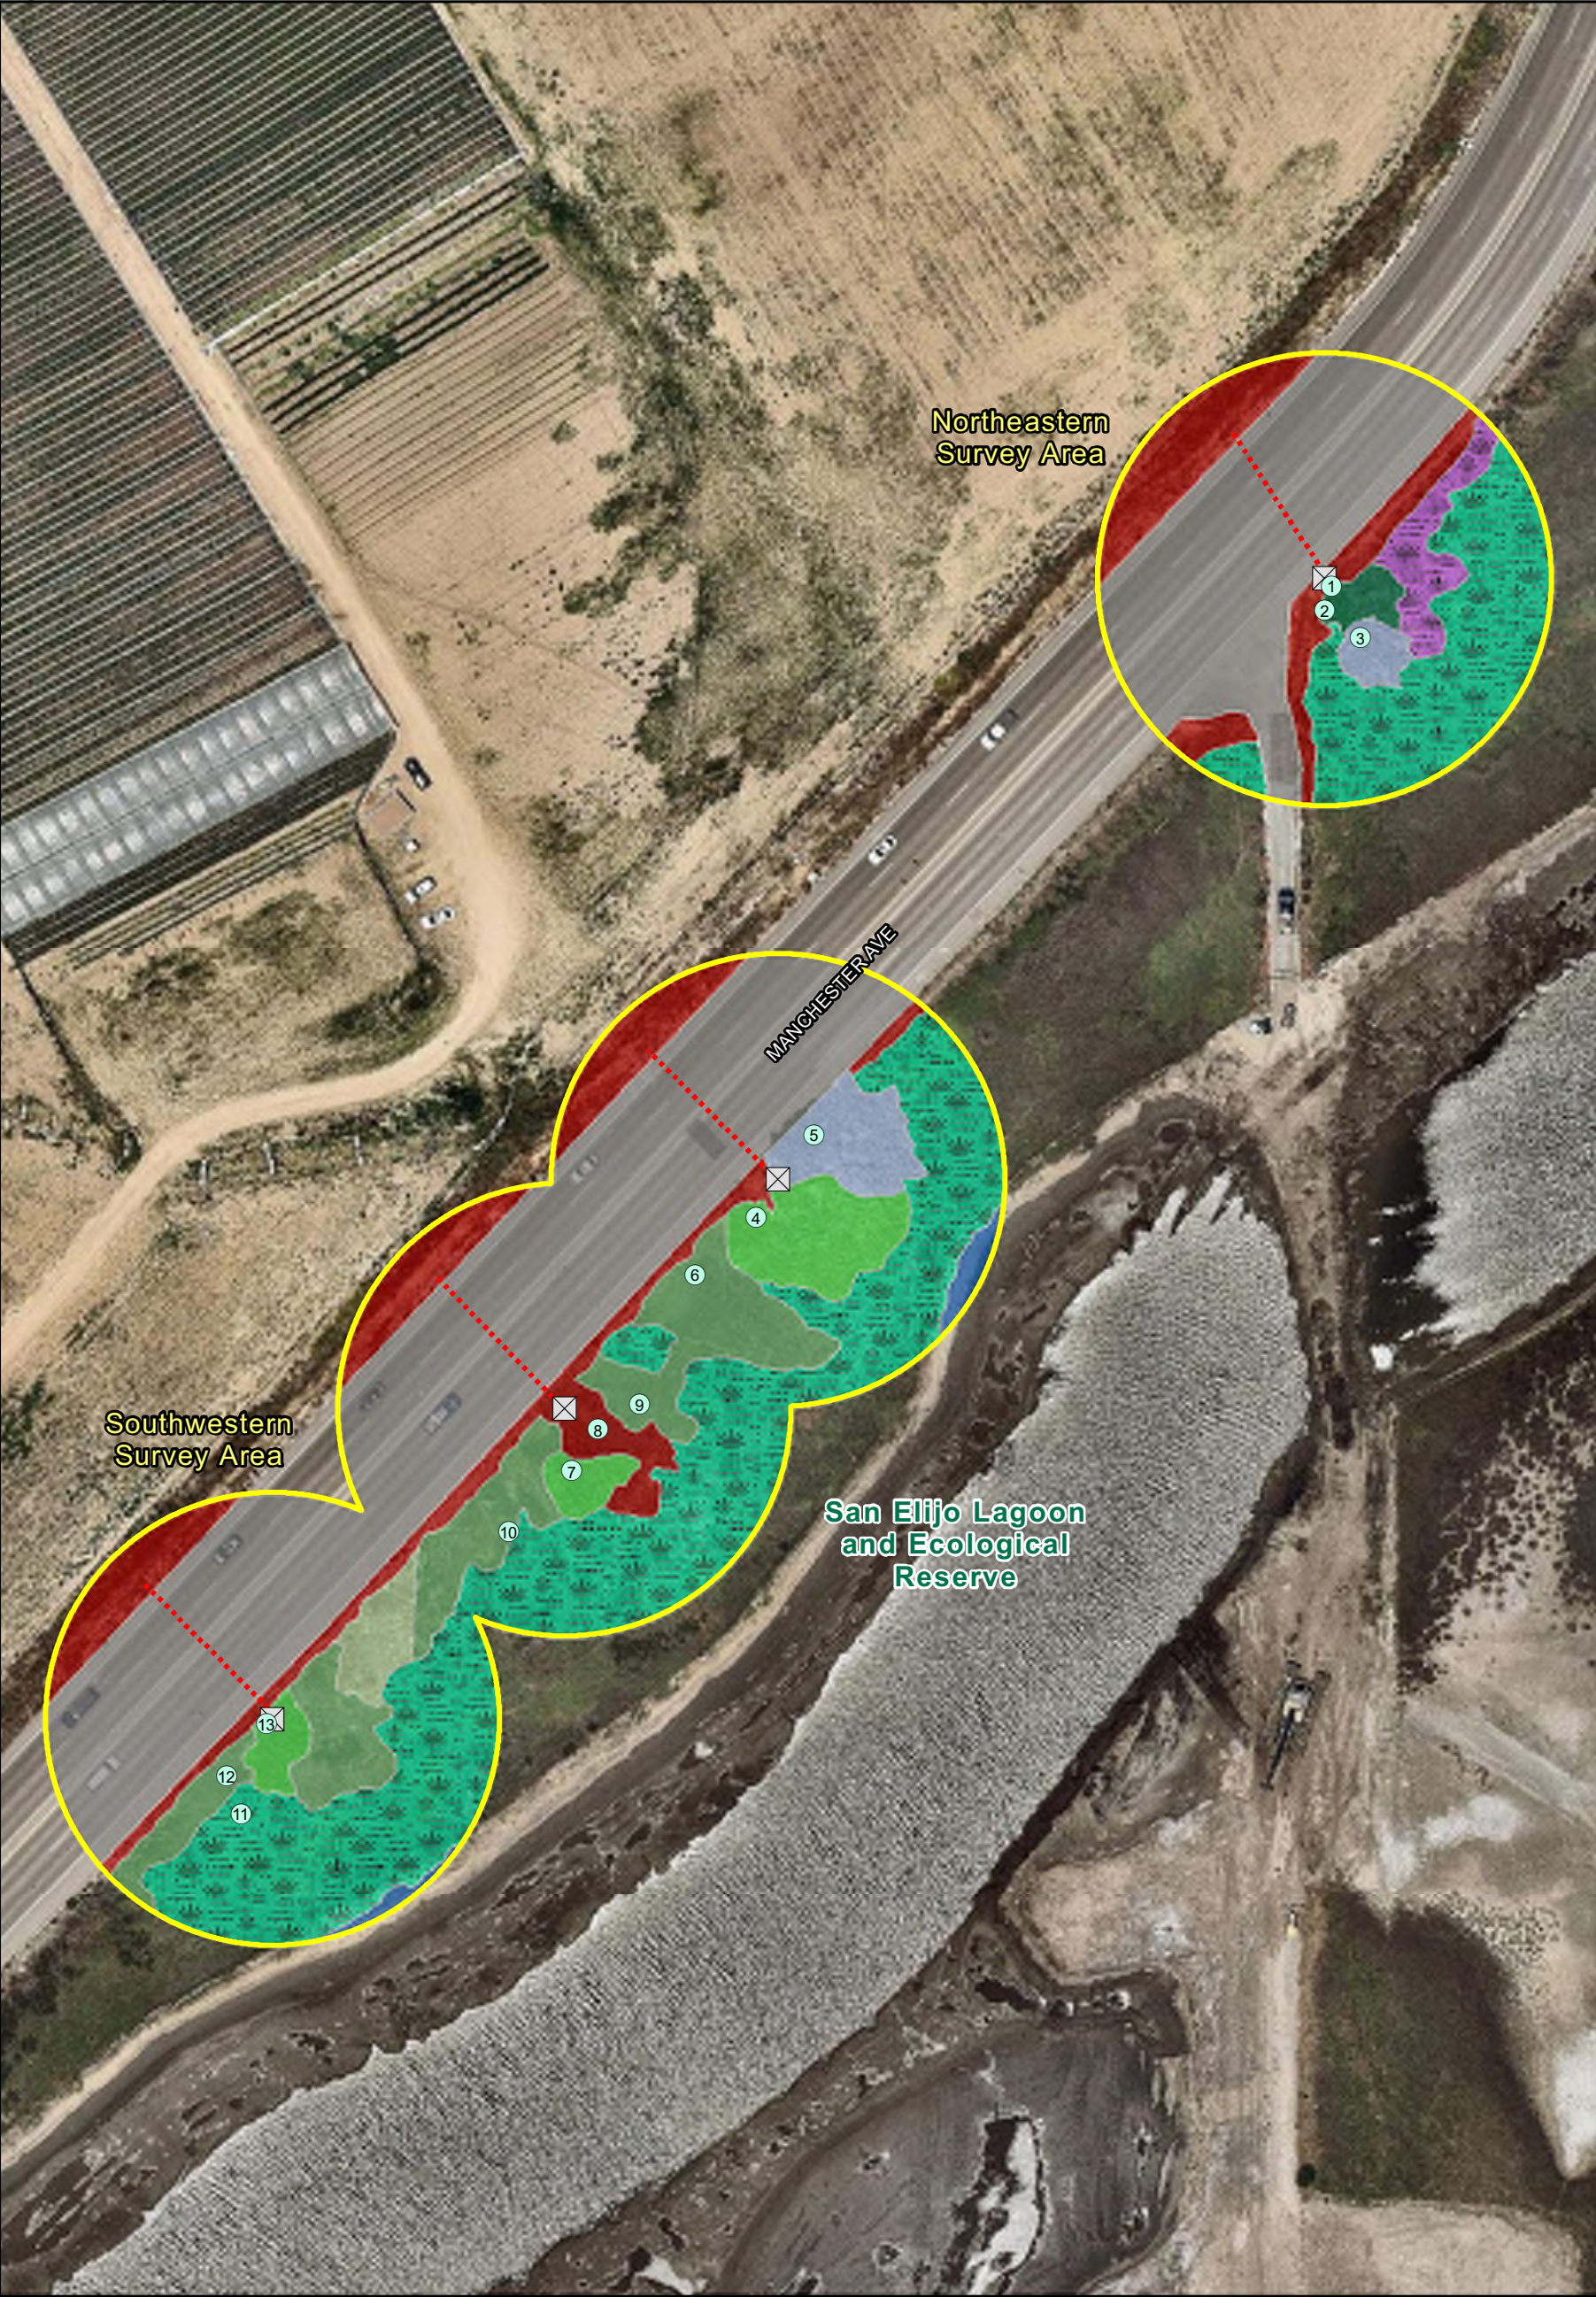
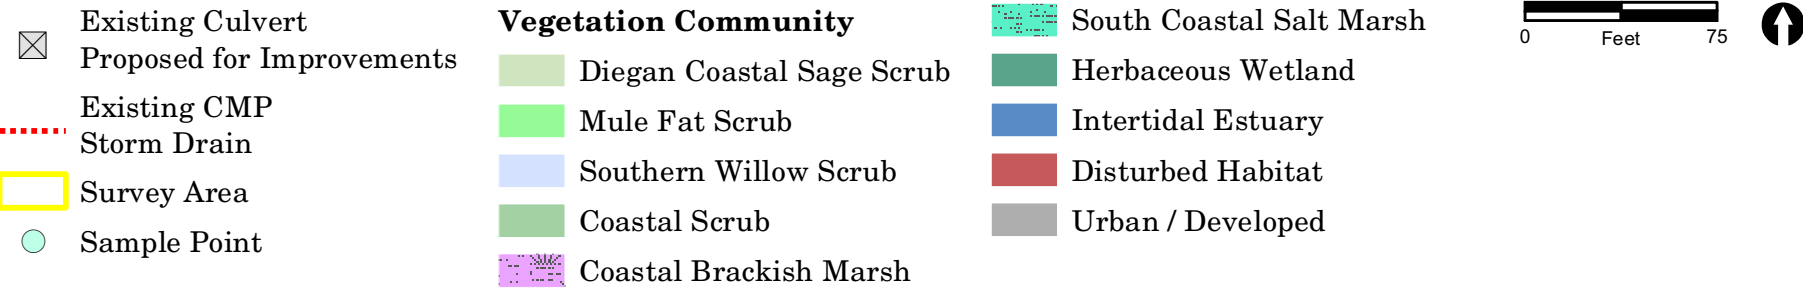
FIGURE 4
Existing Biological Resources

The following ten vegetation communities or land cover types were mapped within the survey areas: south coastal salt marsh, coastal brackish marsh, herbaceous wetland, southern willow scrub, mule fat scrub, coastal scrub, intertidal estuary, Diegan coastal sage scrub, disturbed habitat, and urban/developed land (Figure 4). These vegetation communities and land cover types, along with their corresponding Holland/Oberbauer code and acreage within the survey areas, are summarized in Table 1 below. A brief description of each community, including the dominant plant species observed, is also provided below.

Herbaceous wetland occurs as a small patch around the outfall of the existing culvert in the Northeastern Survey Area (see Figure 4). This patch is dominated by great marsh evening-primrose, which has a vegetation cover of approximately 50 percent here (Photograph 2).

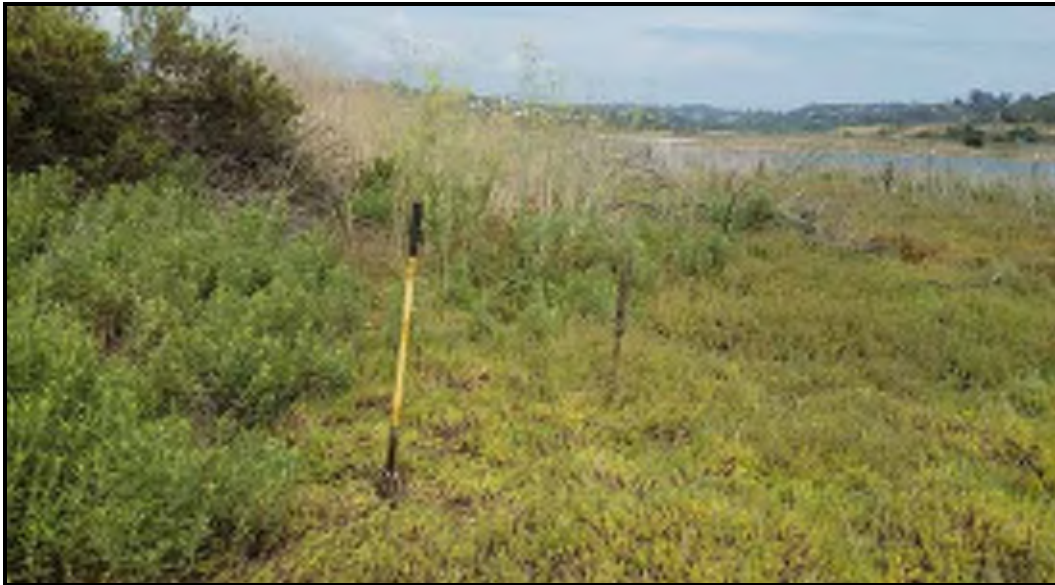
PHOTOGRAPH 1
View of South Coastal Salt Marsh, Facing Northeast

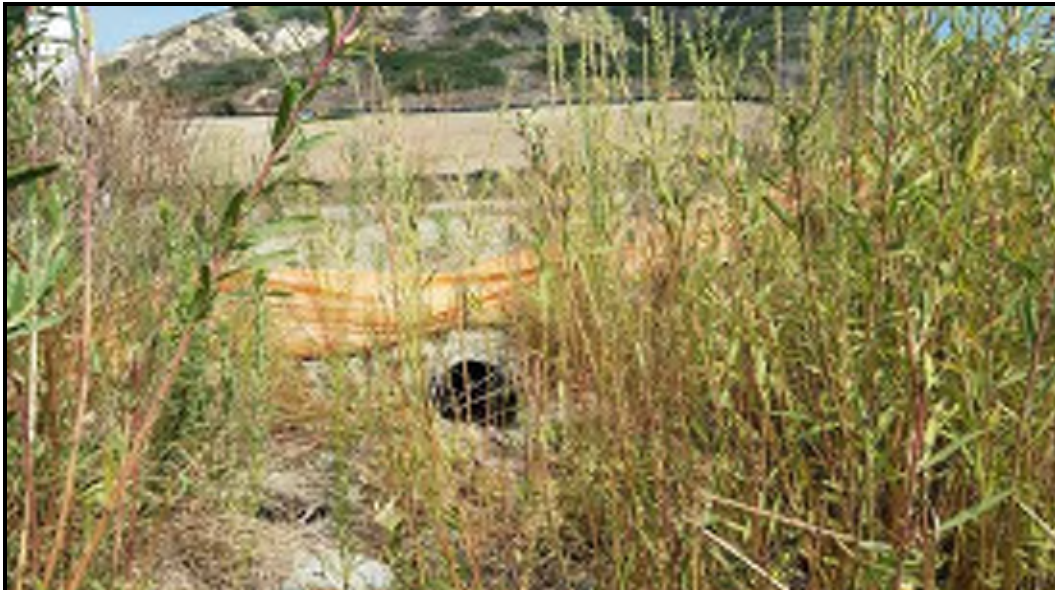
PHOTOGRAPH 2
View of Herbaceous Wetland, Facing Northwest

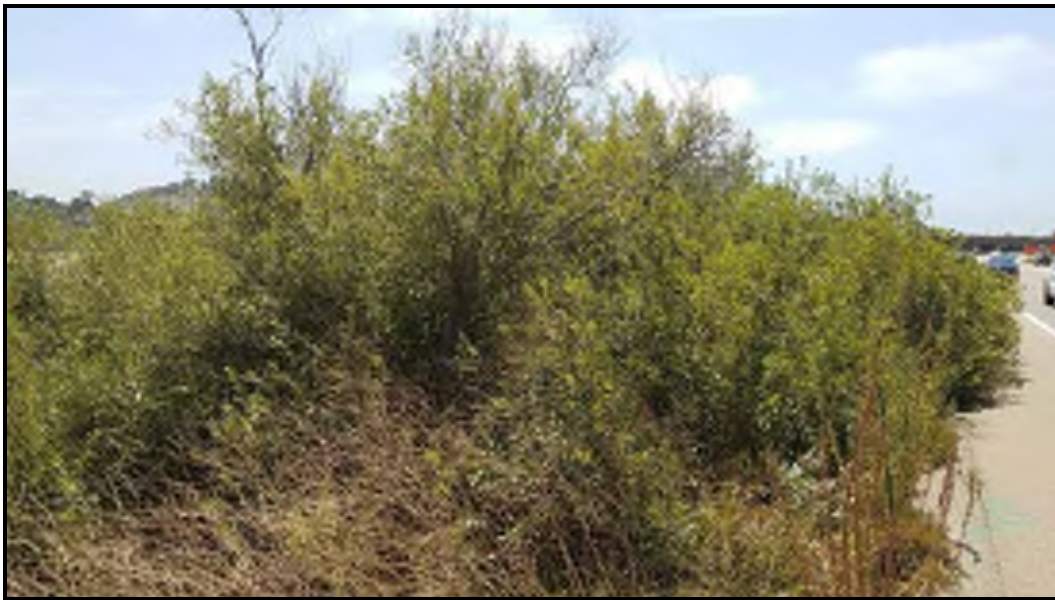
PHOTOGRAPH 3
View of Southern Willow Scrub, Facing Southwest

one arroyo willow, with horseweed (*Erigeron canadensis*; FACU) and great marsh evening-primrose in the understory. Aside from being dominated by arroyo willow, the patch of southern willow scrub in the Southwestern Survey Area also contains scattered mule fat (*Baccharis salicifolia*; FAC; Photograph 3).

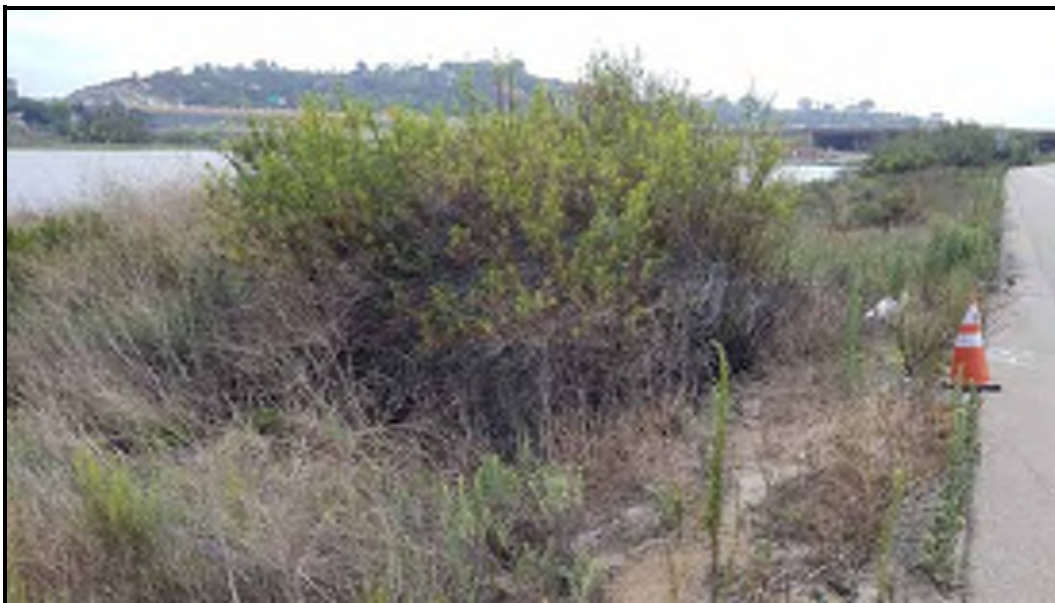
PHOTOGRAPH 4
View of Mule Fat Scrub, Facing Southwest

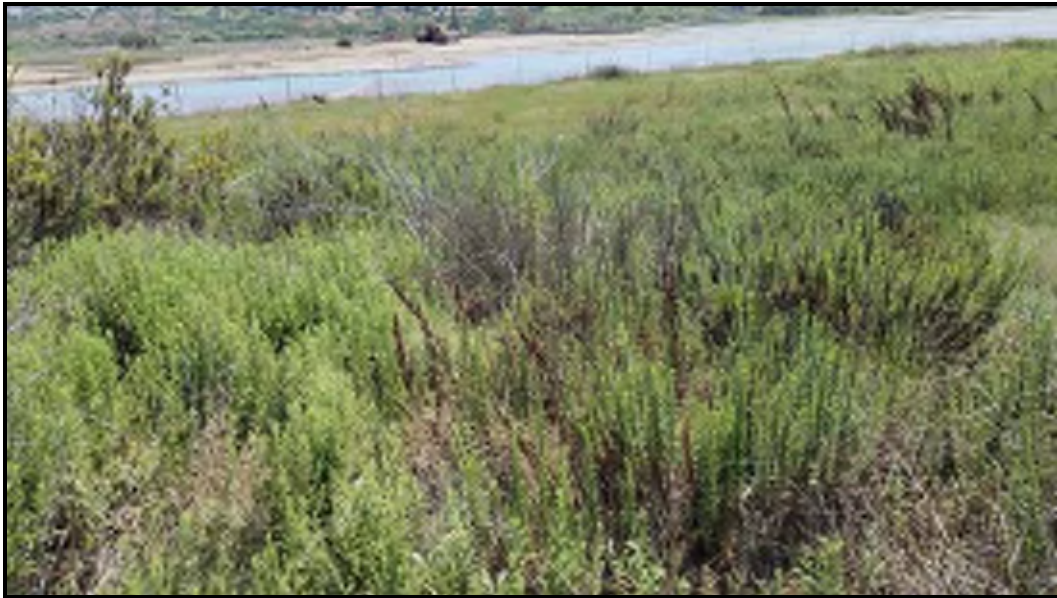
PHOTOGRAPH 5
View of Coastal Scrub, Facing East

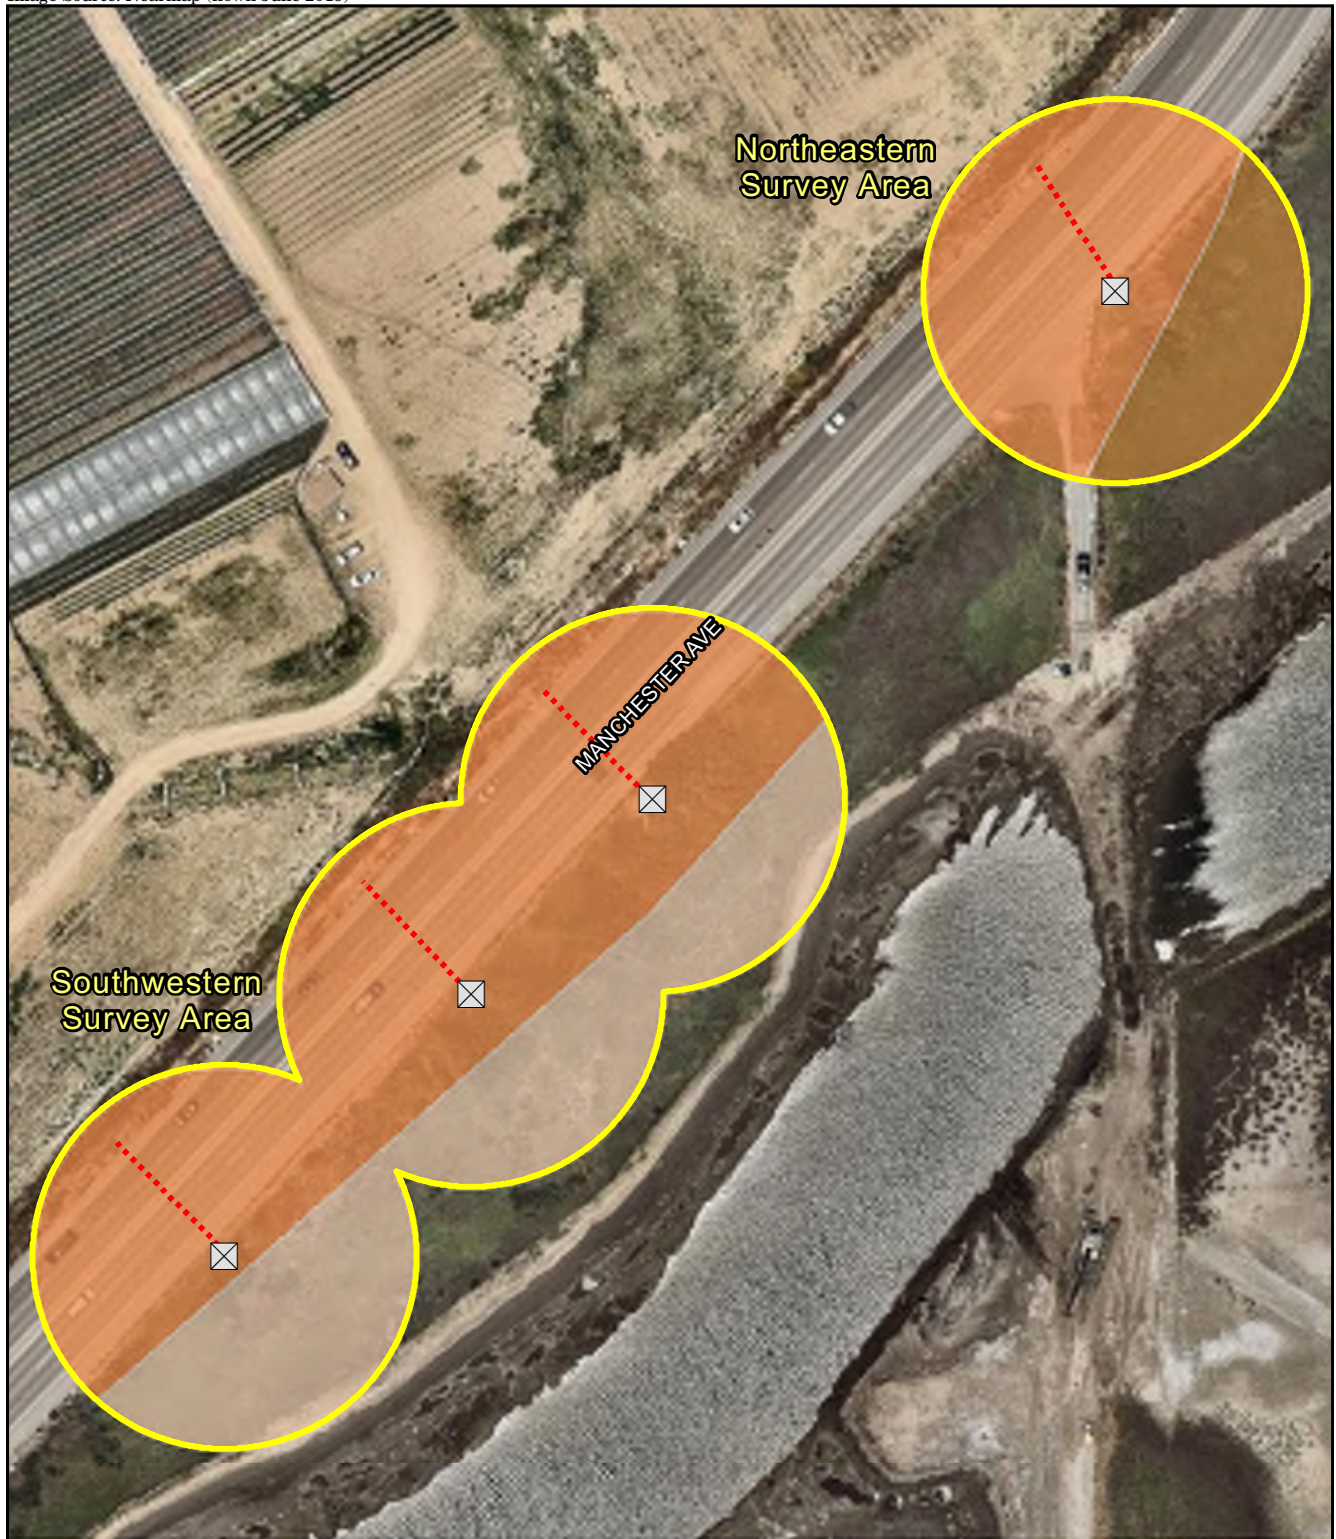
FIGURE 5
Project Location on Soil Map

Soil types mapped within the survey areas are shown on Figure 5 and include Corralitos loamy sand, 5 to 9 percent slopes; Lagoons of San Diego Area; and Tidal flats. Lagoons of San Diego Area and Tidal flats are both listed as hydric soils in San Diego County.

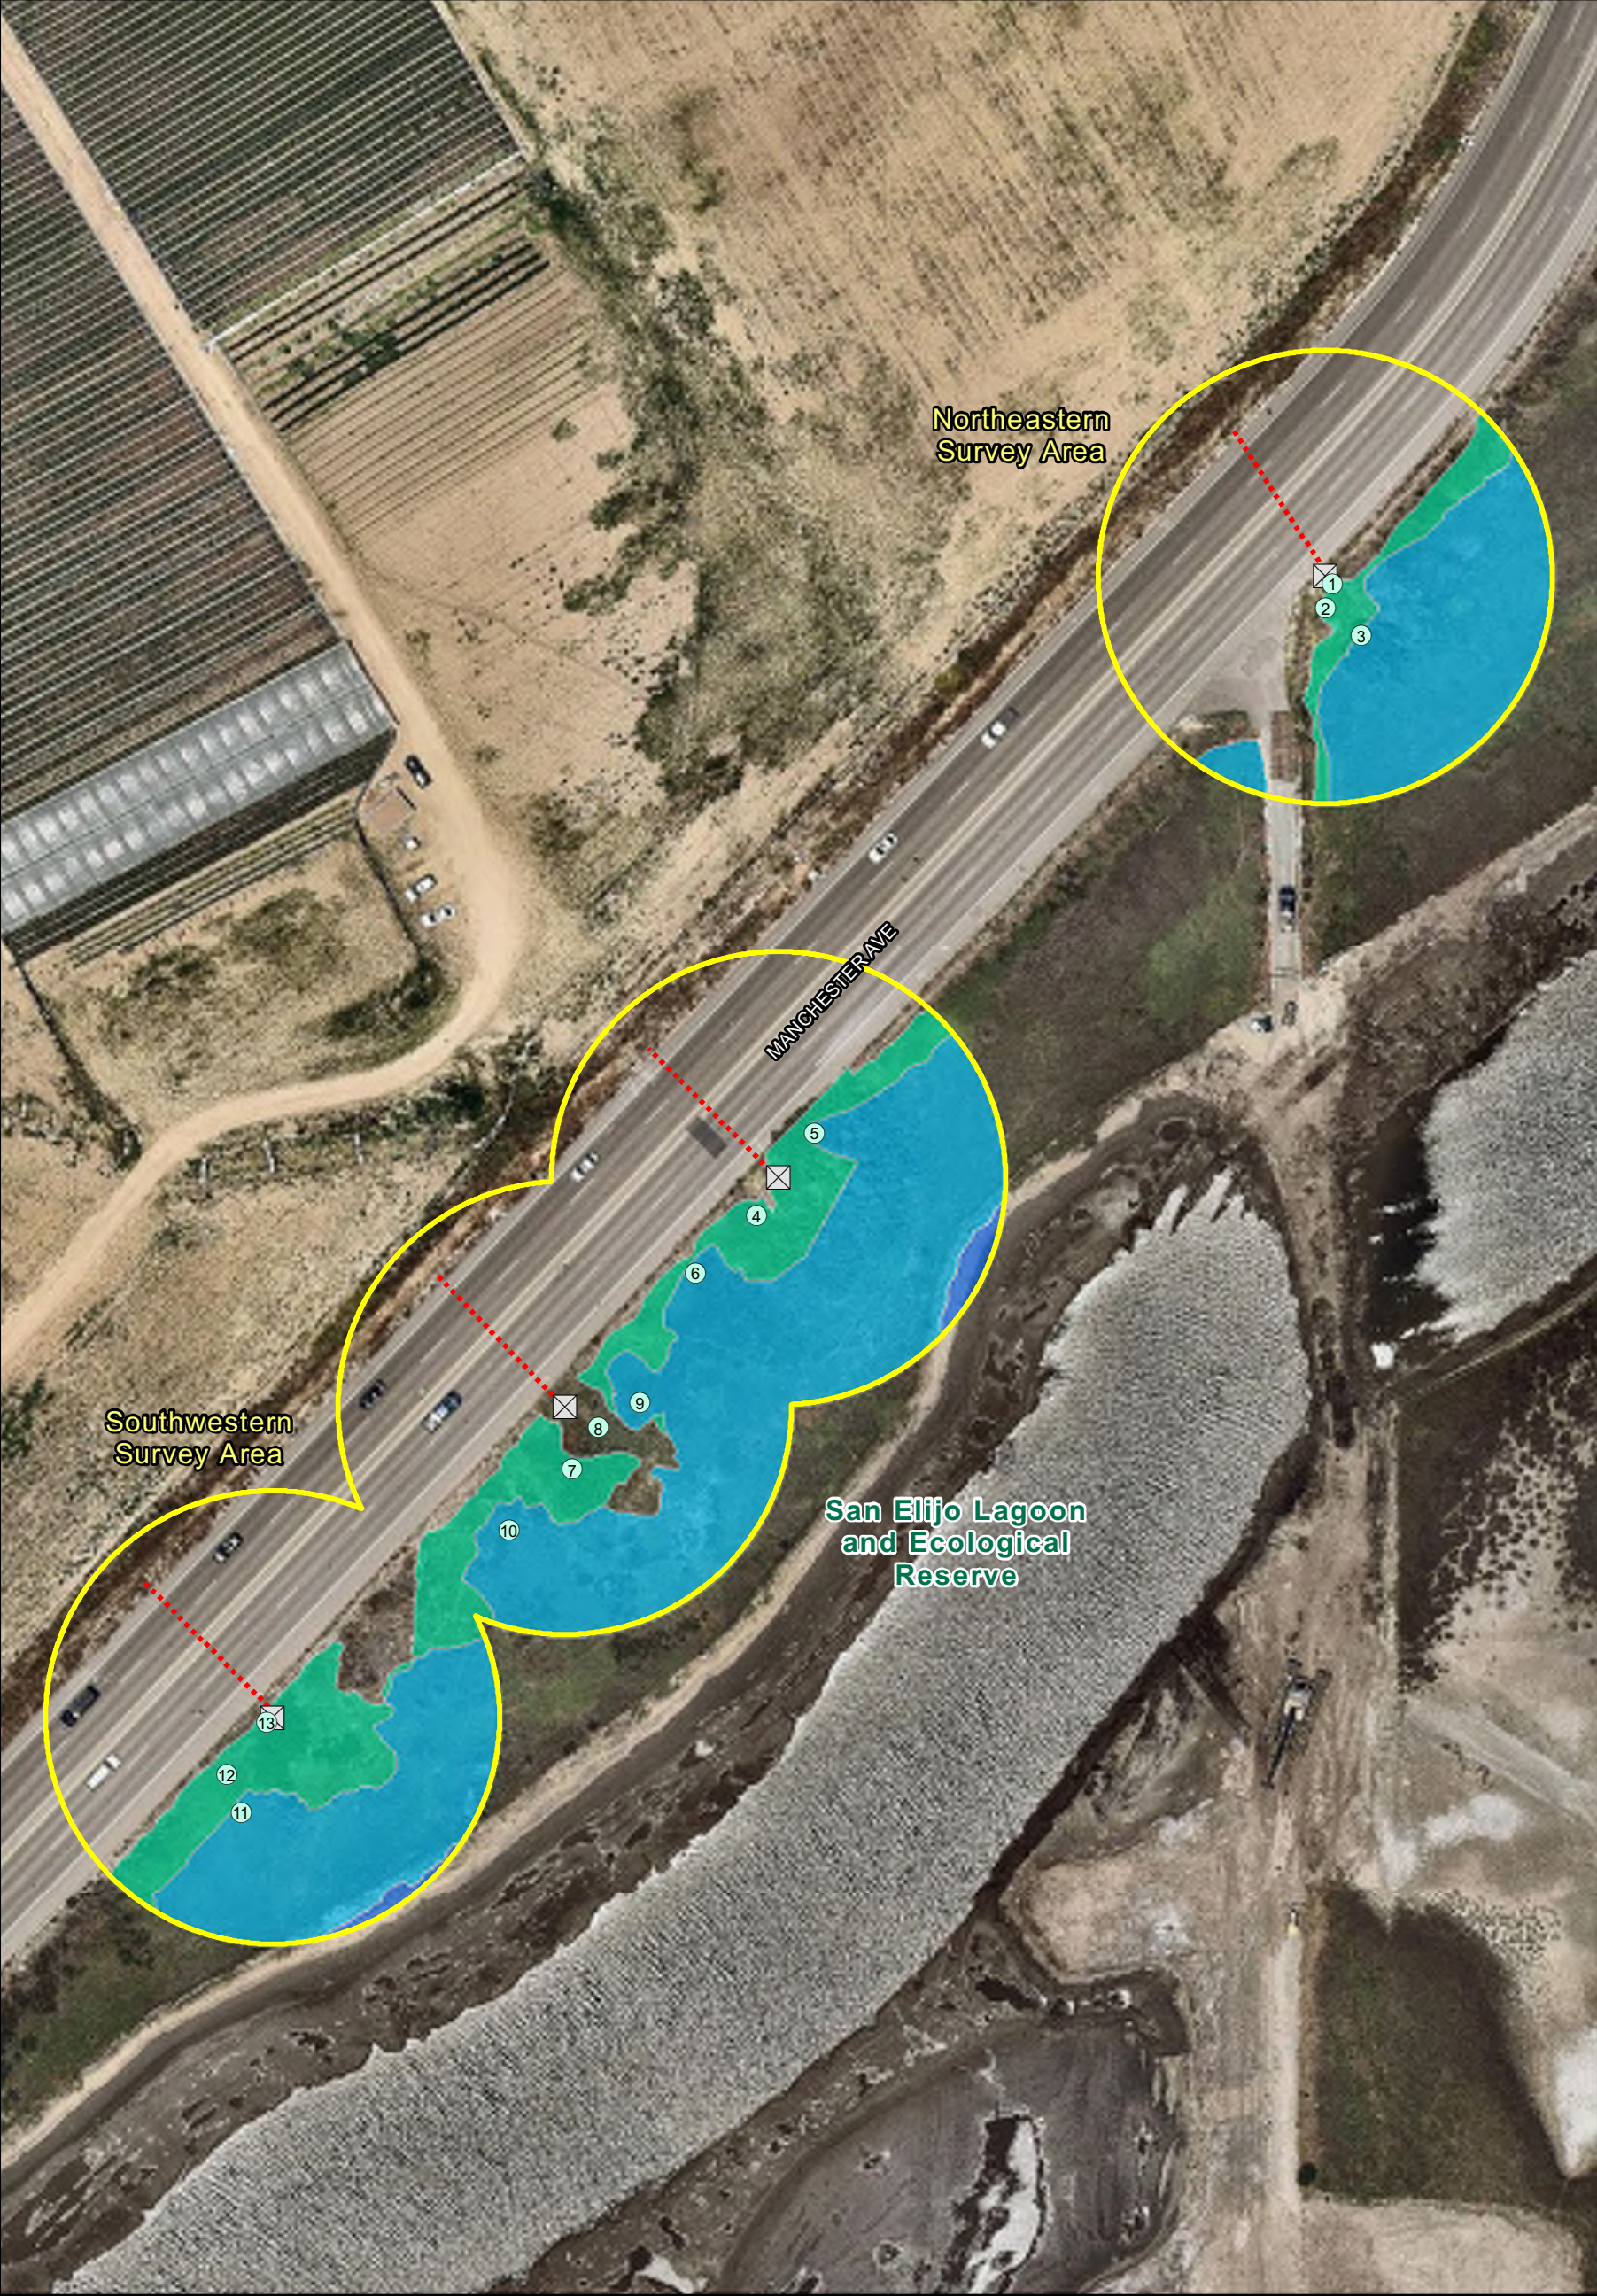
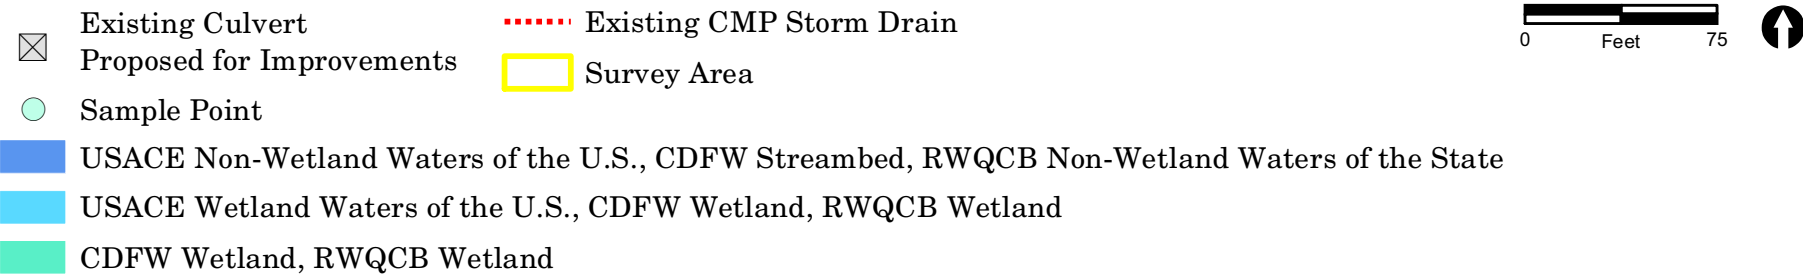
FIGURE 6
Jurisdictional Resources

Acreages of jurisdictional waters are provided in Table 2 by jurisdiction and resource type. Figure 6 shows the locations of the jurisdictional waters identified within the survey areas for each agency jurisdiction.

Table 2 Existing Jurisdictional Waters within the Survey Areas	
Jurisdictional Areas	Total Acres (linear feet)
USACE Total Jurisdiction	0.965 (142)
Wetland Waters of the U.S.	0.944
Non-wetland Waters of the U.S.**	0.021 (142)
CDFW and RWQCB Total Jurisdictional Areas*	1.296 (142)
Wetland Waters of the State (Riparian Habitat)	1.275
Non-wetland Waters of the State (Streambed)**	0.021 (142)
*CDFW/RWQCB area of jurisdiction includes all USACE jurisdictional waters.	
**Non-wetland waters/streambed area not included in the wetland/riparian areas so that no area is counted twice for the same jurisdiction.

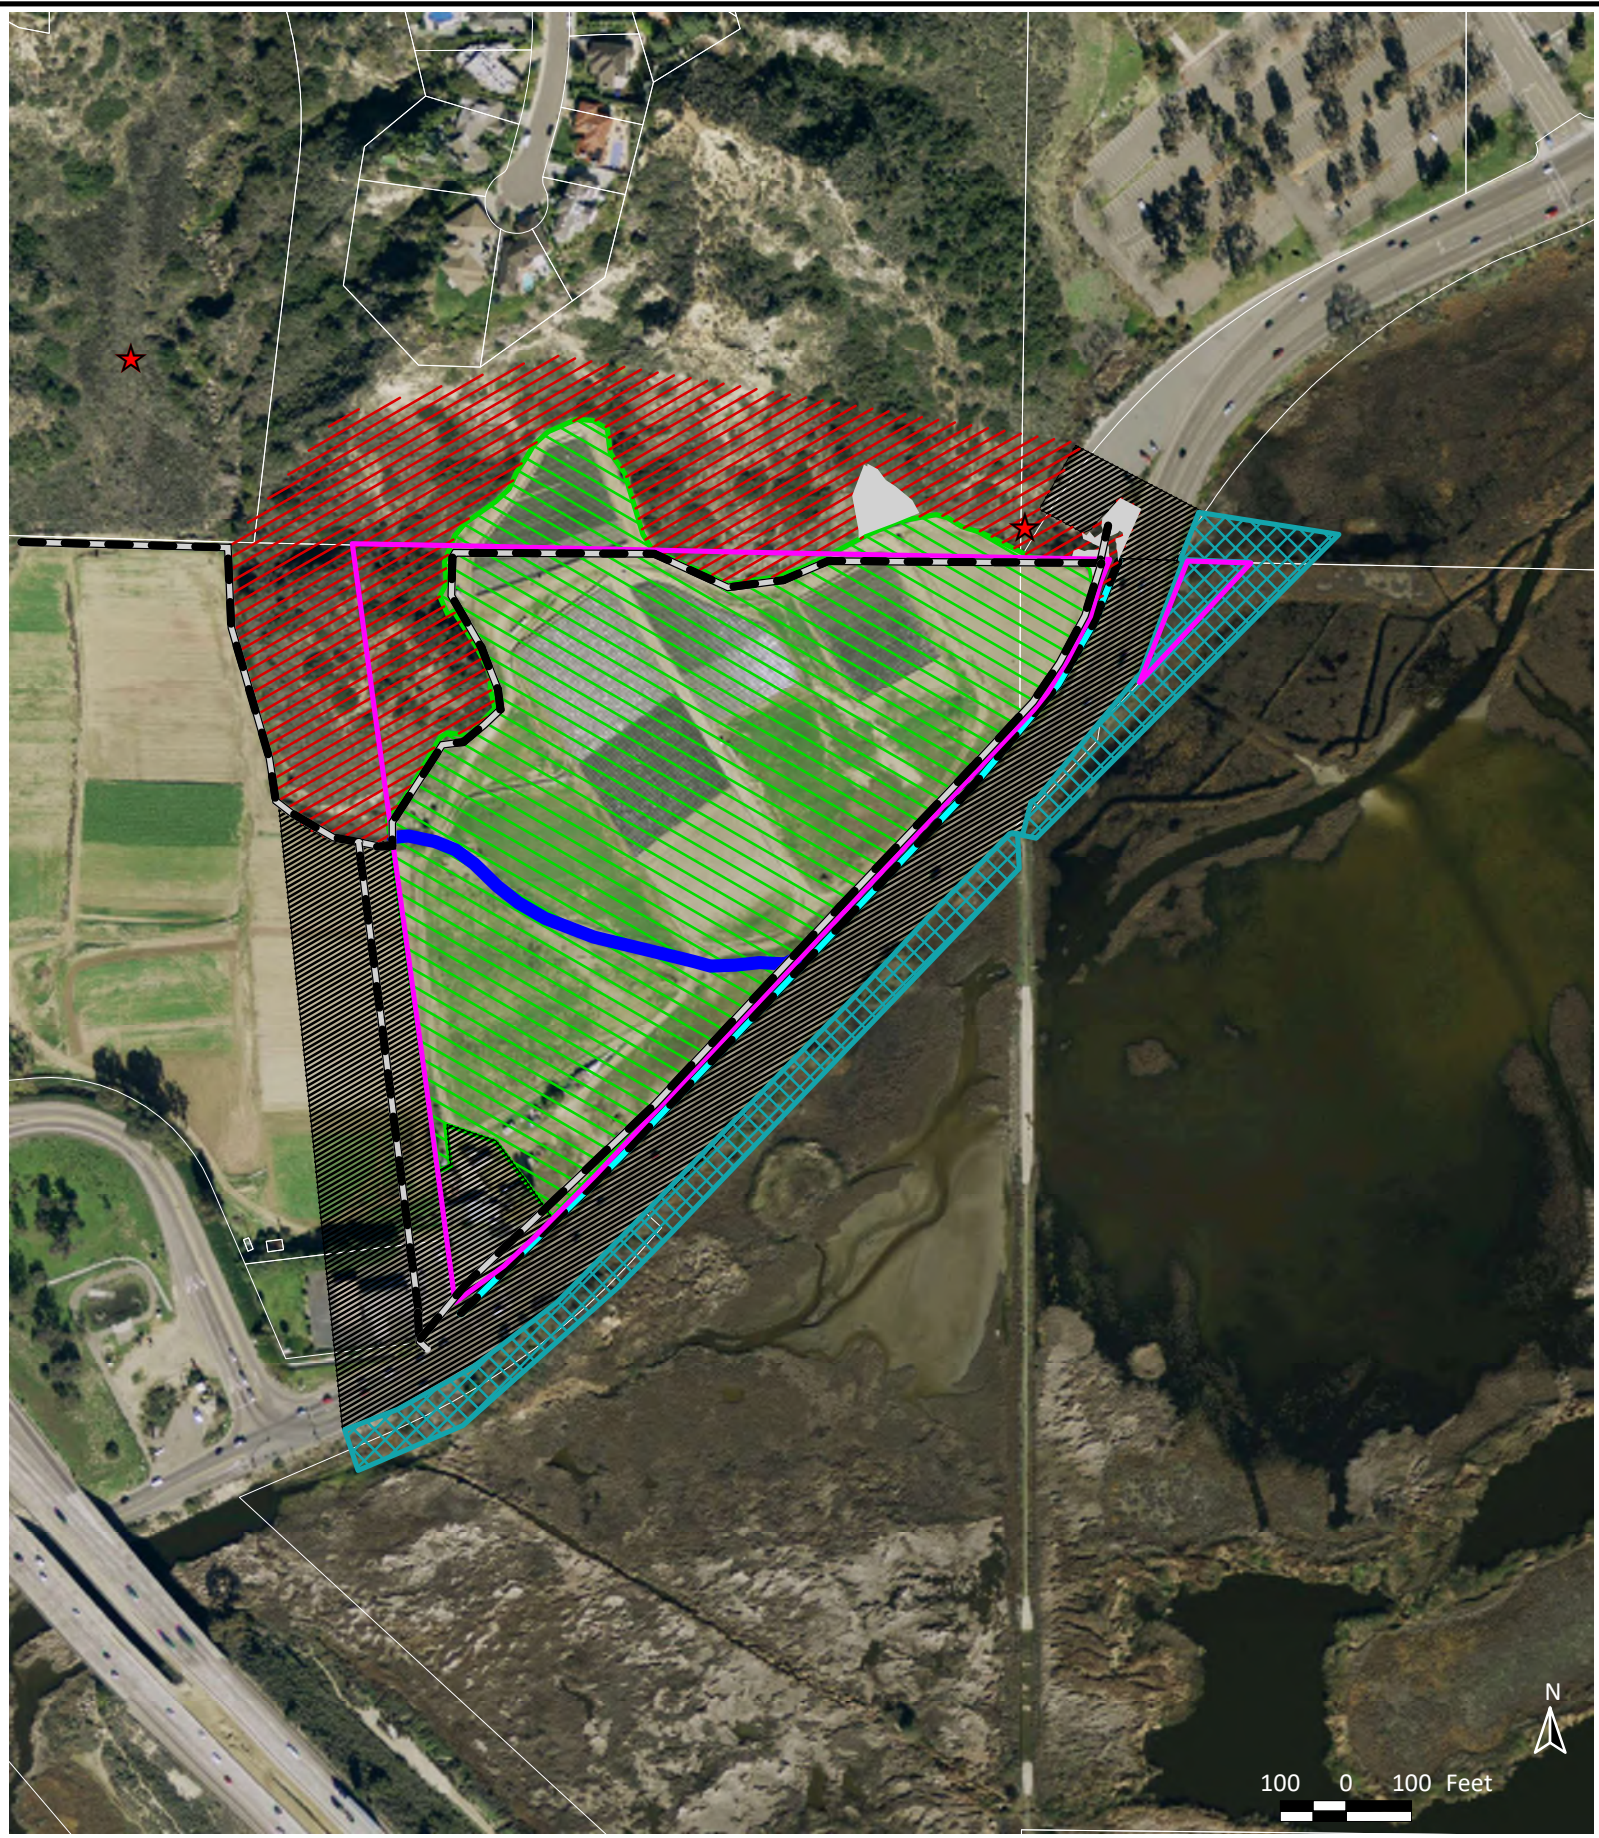
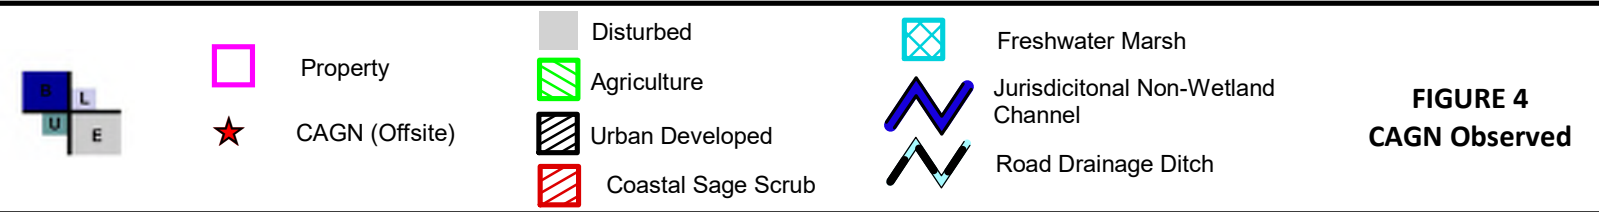
FIGURE 4
CAGN Observed

Spring 2019 protocol CAGN surveys were completed and none were observed onsite. Gnatcatchers were observed offsite immediately offsite in the north east corner and to the north (in the canyon). No sensitive wildlife species were documented onsite. Due to the site conditions and the implementation of the proposed preventative mitigation measures (see Section 6.3, below), no impacts to sensitive wildlife species are expected to occur and specific mitigation measures would not be required.
